Small components. Big impact.

Cabling of PV installations – Key factors for a successful long-time reliability

Cabling of PV systems – You can't manage the unknown

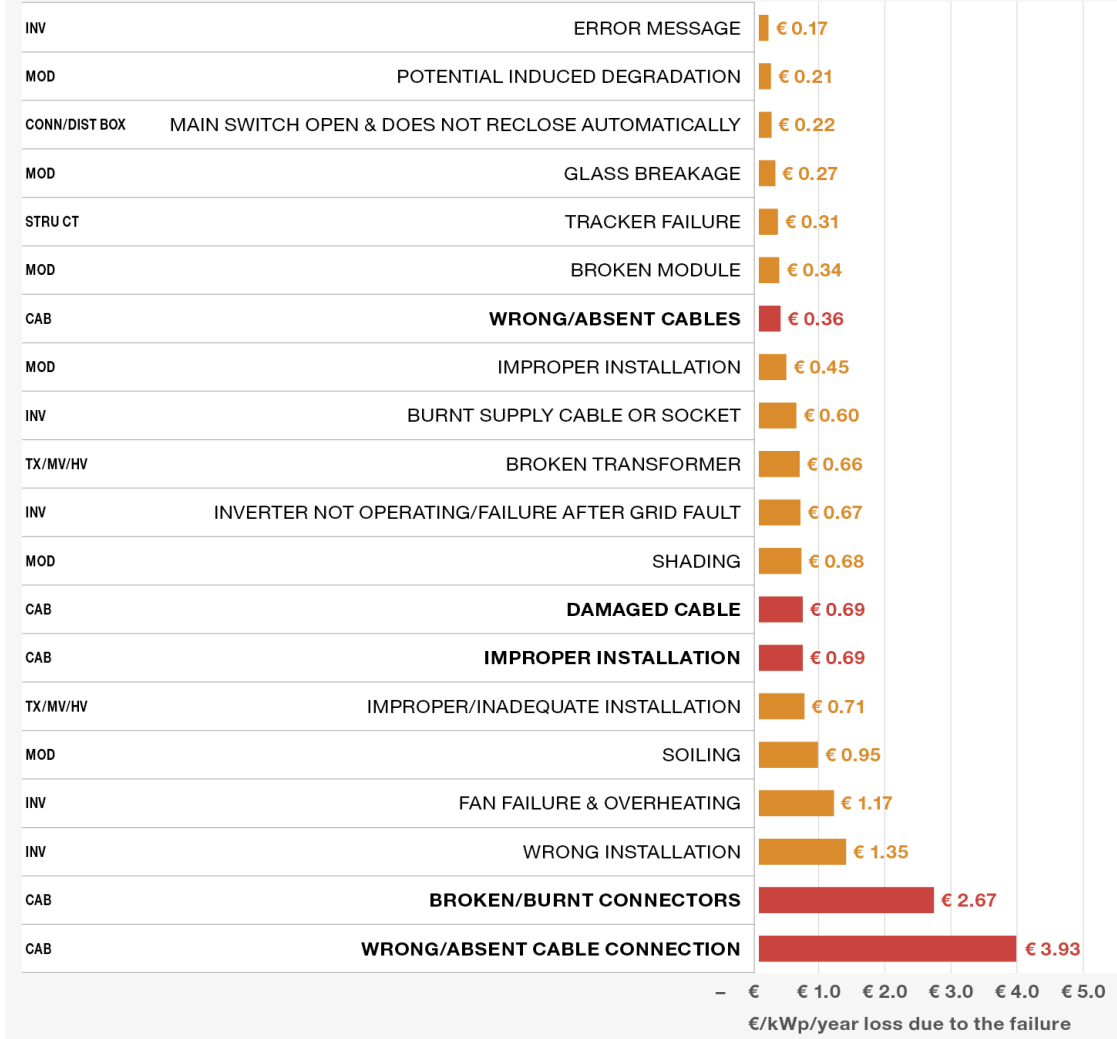
Top 20 technical failures

- CPN (cost priority number) = cost-based failure mode and effects analysis (FMEA)
- Method was applied to database of >1 million documented failure claims (empirical and statistical)
- Technical failures/risks and their economic impact due downtime and/or power loss & repair/substitution costs
- Indication of the economic risk (in average) of a specific technical risk

**Cable & connector with huge financial impact
→ Euro/ kWp/ year loss due to the failure**

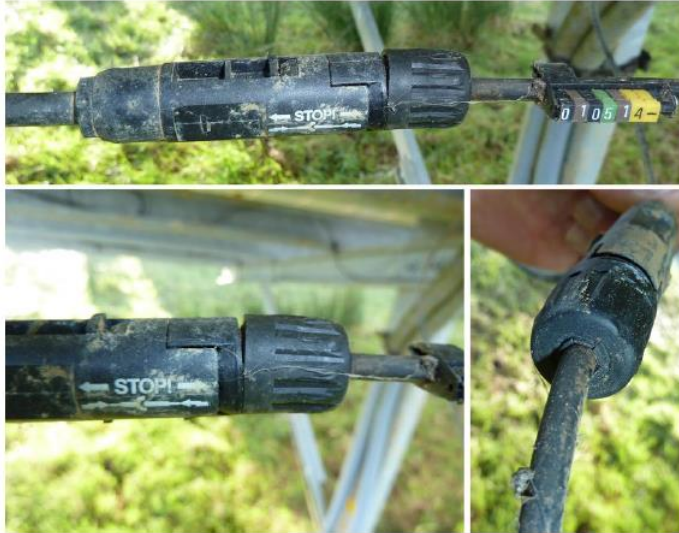
Fig. 4-7: string connector on negative pole of string 0105-14

The cable gland nuts of many connectors were found damaged, obviously because pliers were used for tightening, rather than the appropriate wrench tool with torque control (Mfgr. P/N: 112G0-003344-R1). The nuts were often seen skew on their threads leading to irregular compression of the inner gasket.

Many string connectors could easily be turned by hand on the string cable which suggests that the type of gasket and its compressing cage was not chosen according to the outer cable diameter.

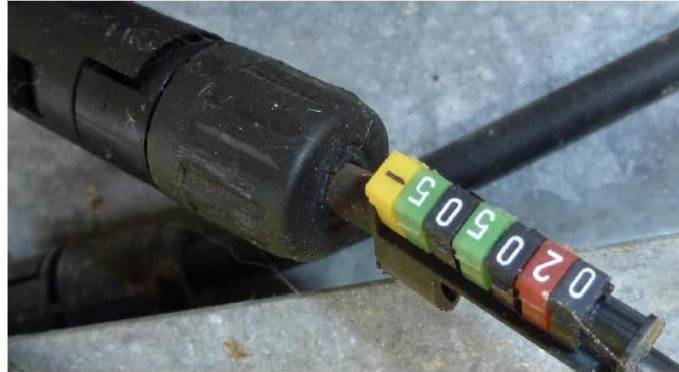
Again, the Sunbolts-compatible connectors of the string (homerun) cables were often found to be assembled in an inappropriate manner with damaged or skewed nuts und easily turnable by hand:

Fig. 4-14: string connector on negative pole of string 0205-05

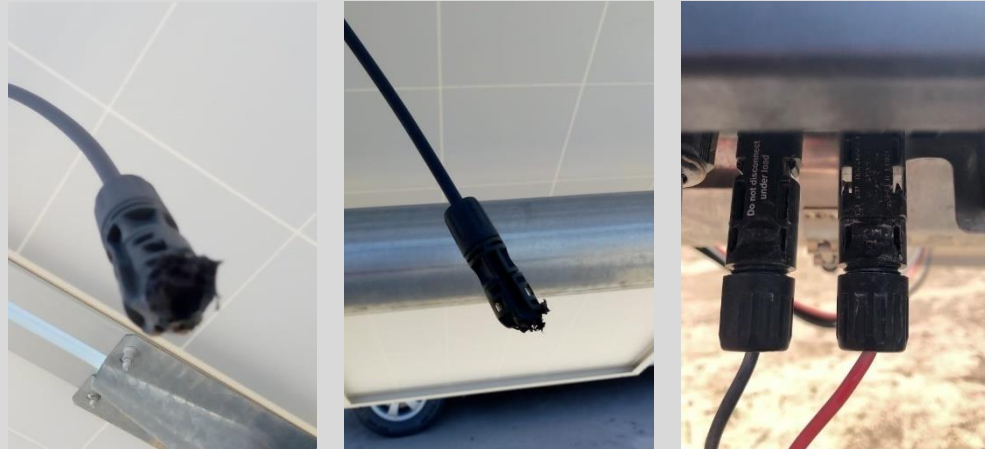
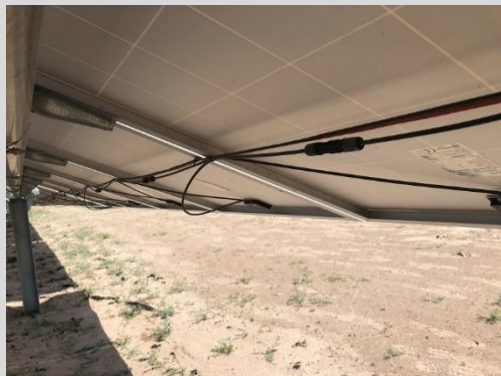
Site location: LATAM
Size: > 500 MW
Inspection: < 6 months after site completion

Failure pattern

- Broken/ burned connectors (several per week)
- Low-voltage at inverter caused by connectors

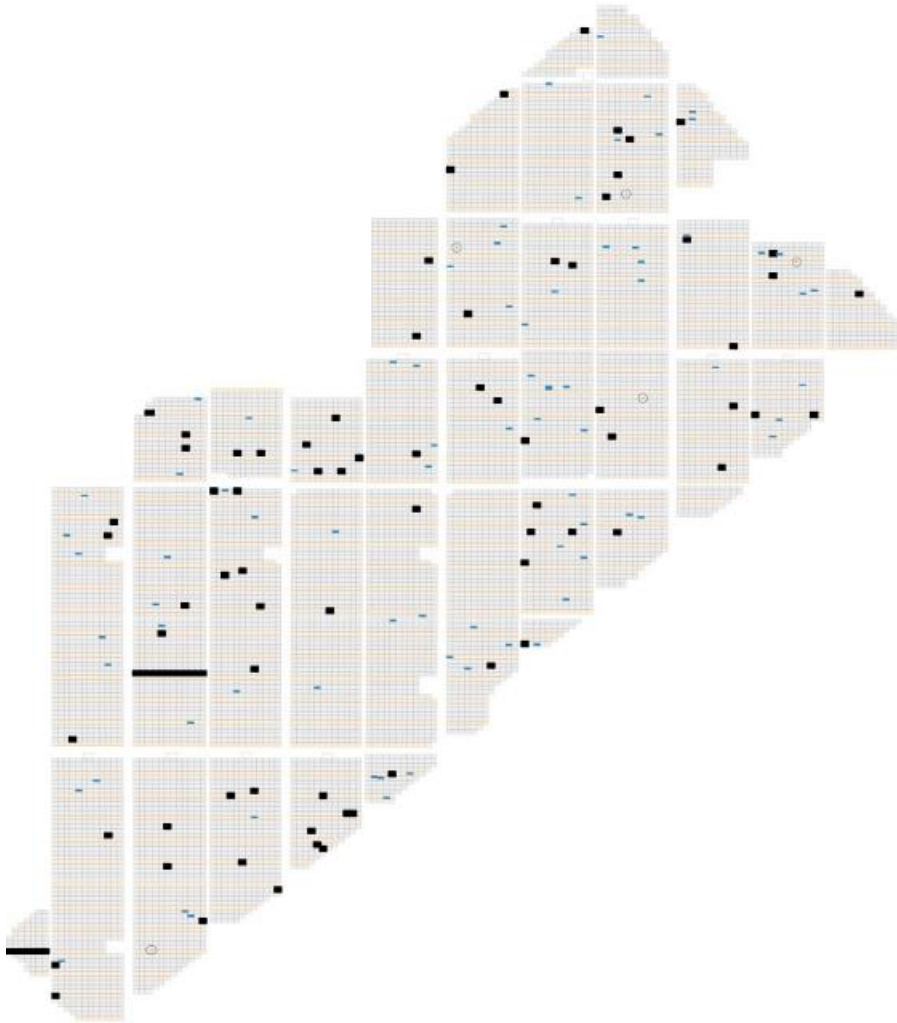
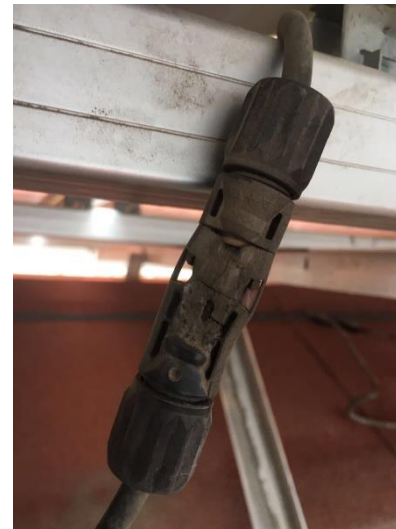
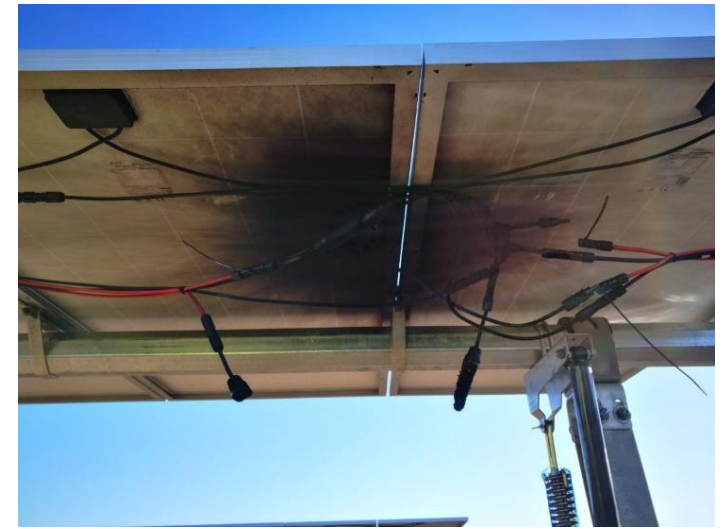
100MW system - 3.112 panels affected so far

No physical damage, but high temperature
-

Mechanical damage, but electrically conducting with high temperature
-

String failure due to completely broken connection mechanically and electrically

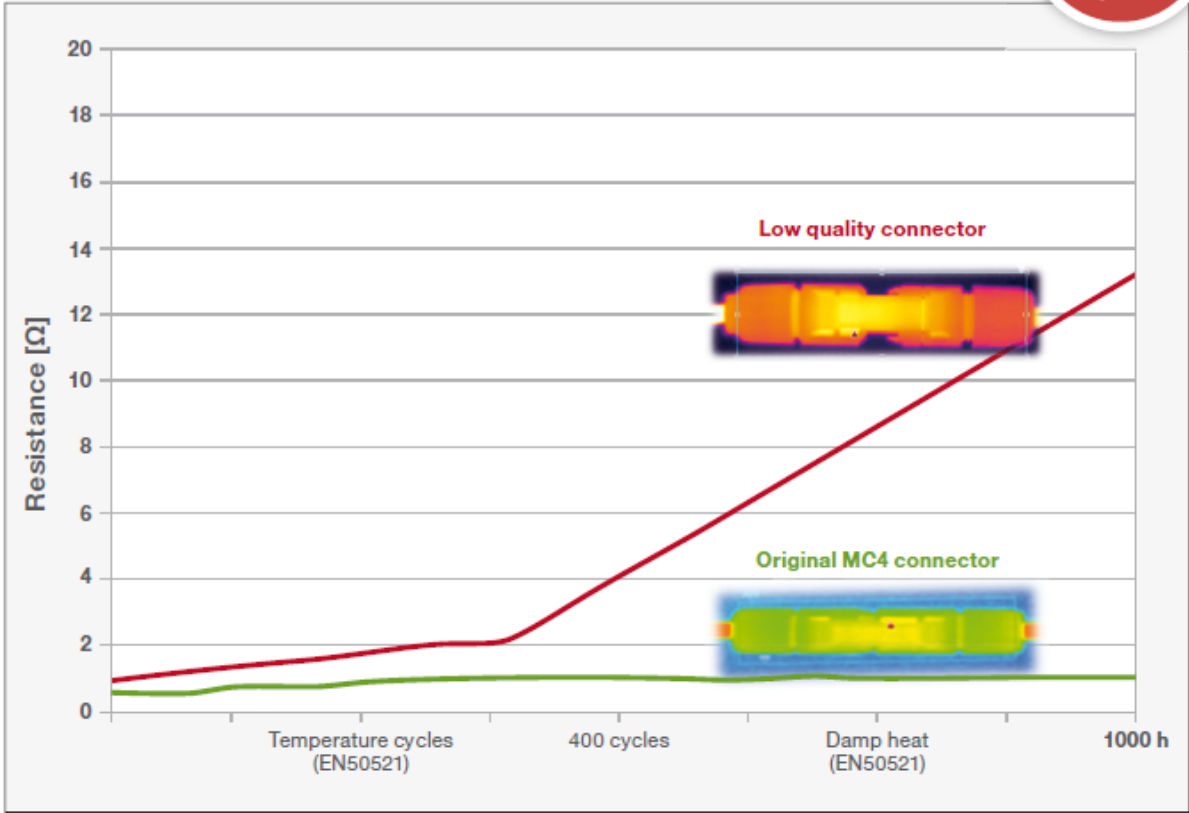
1) Component Quality – Contact Resistance

Initial Measurements and after TCT/DHT

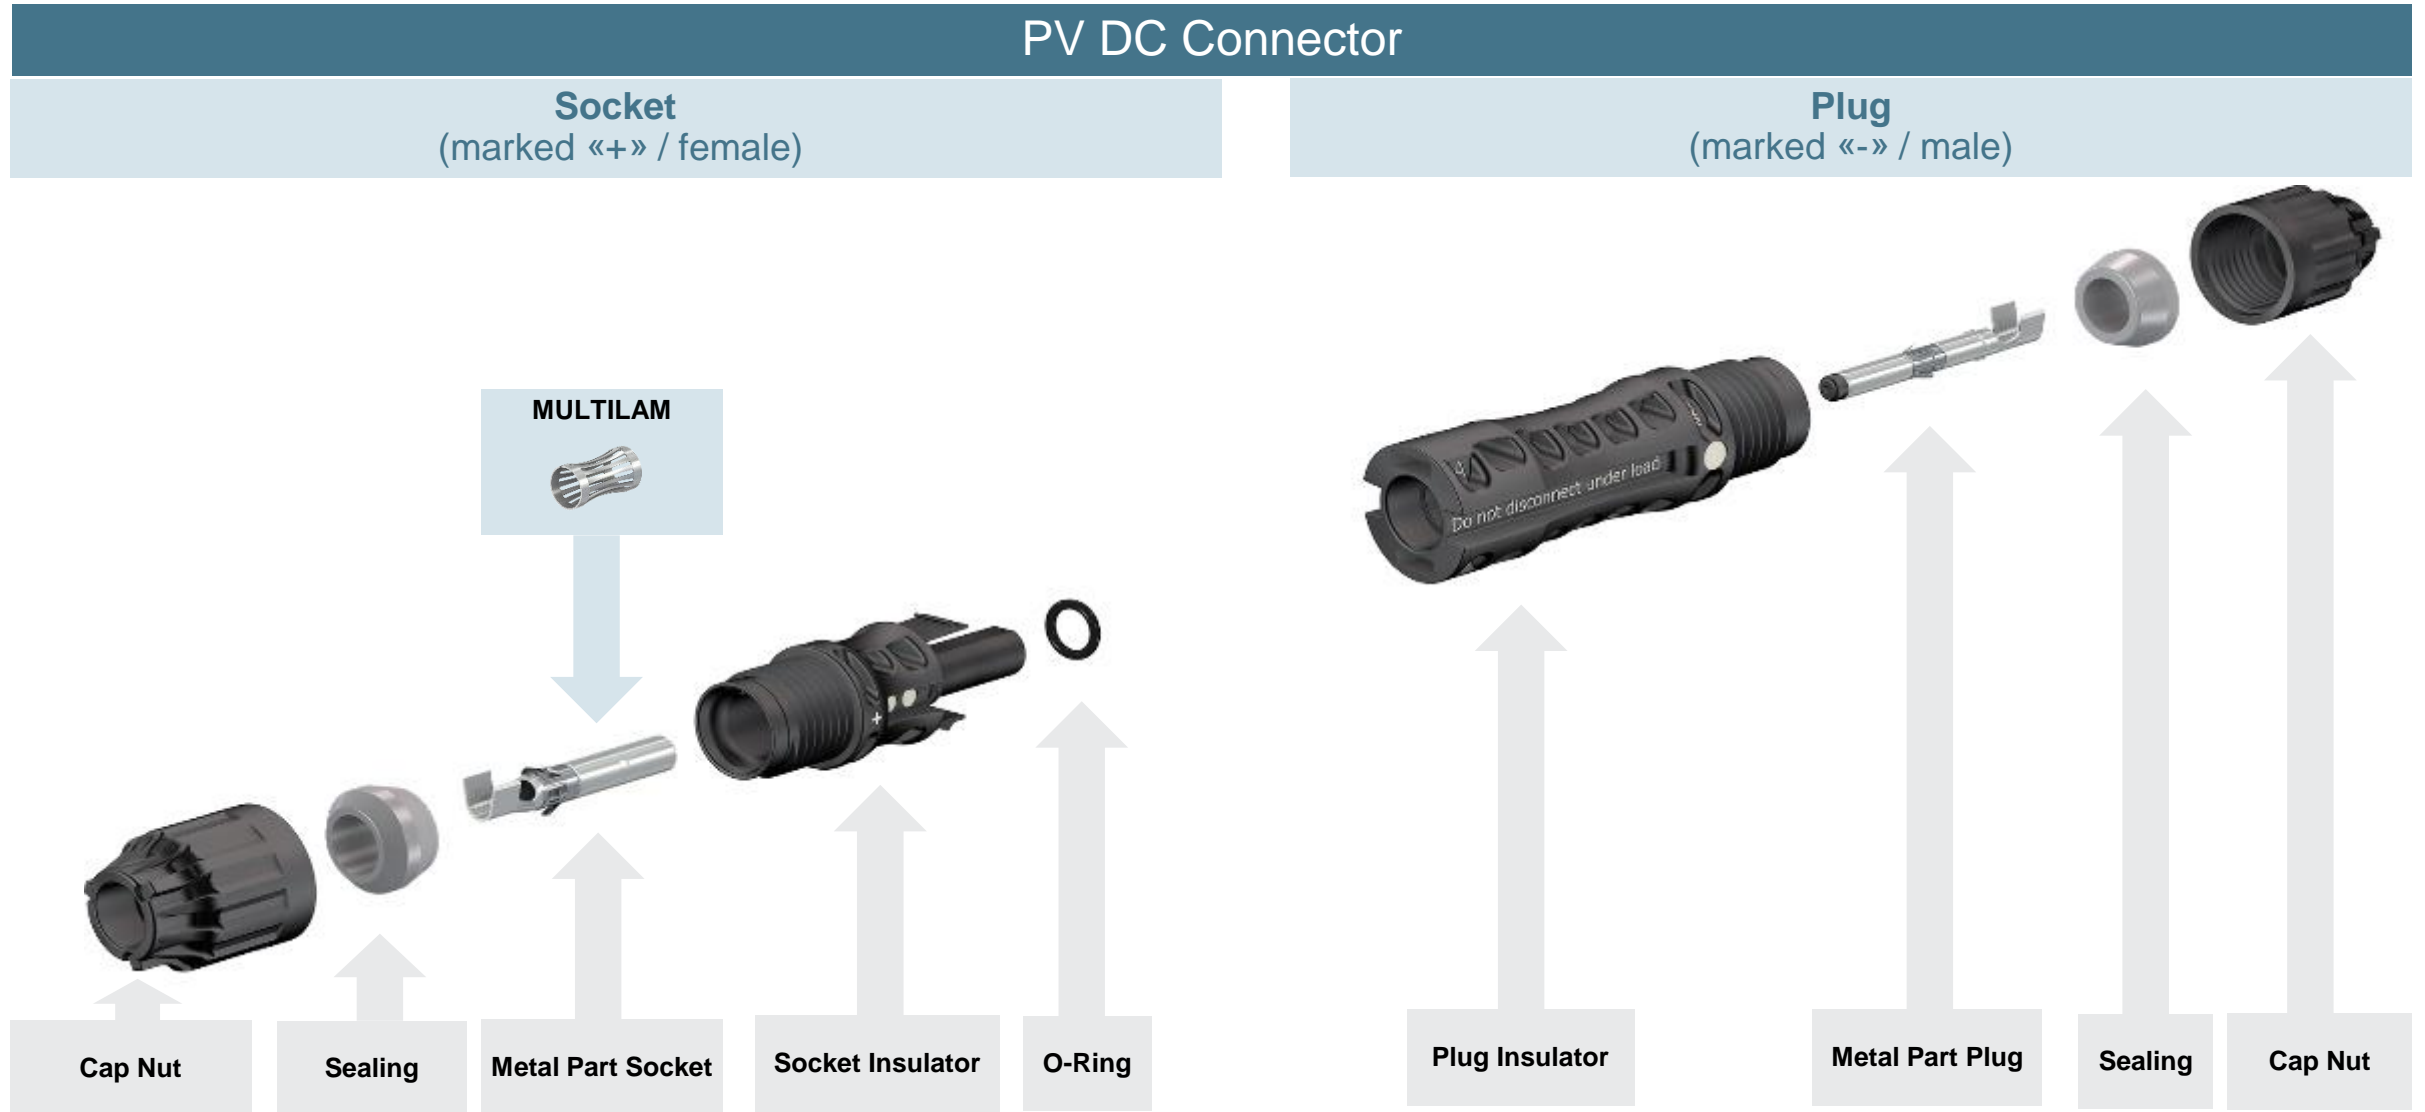
1) Component Quality – PV DC Connector

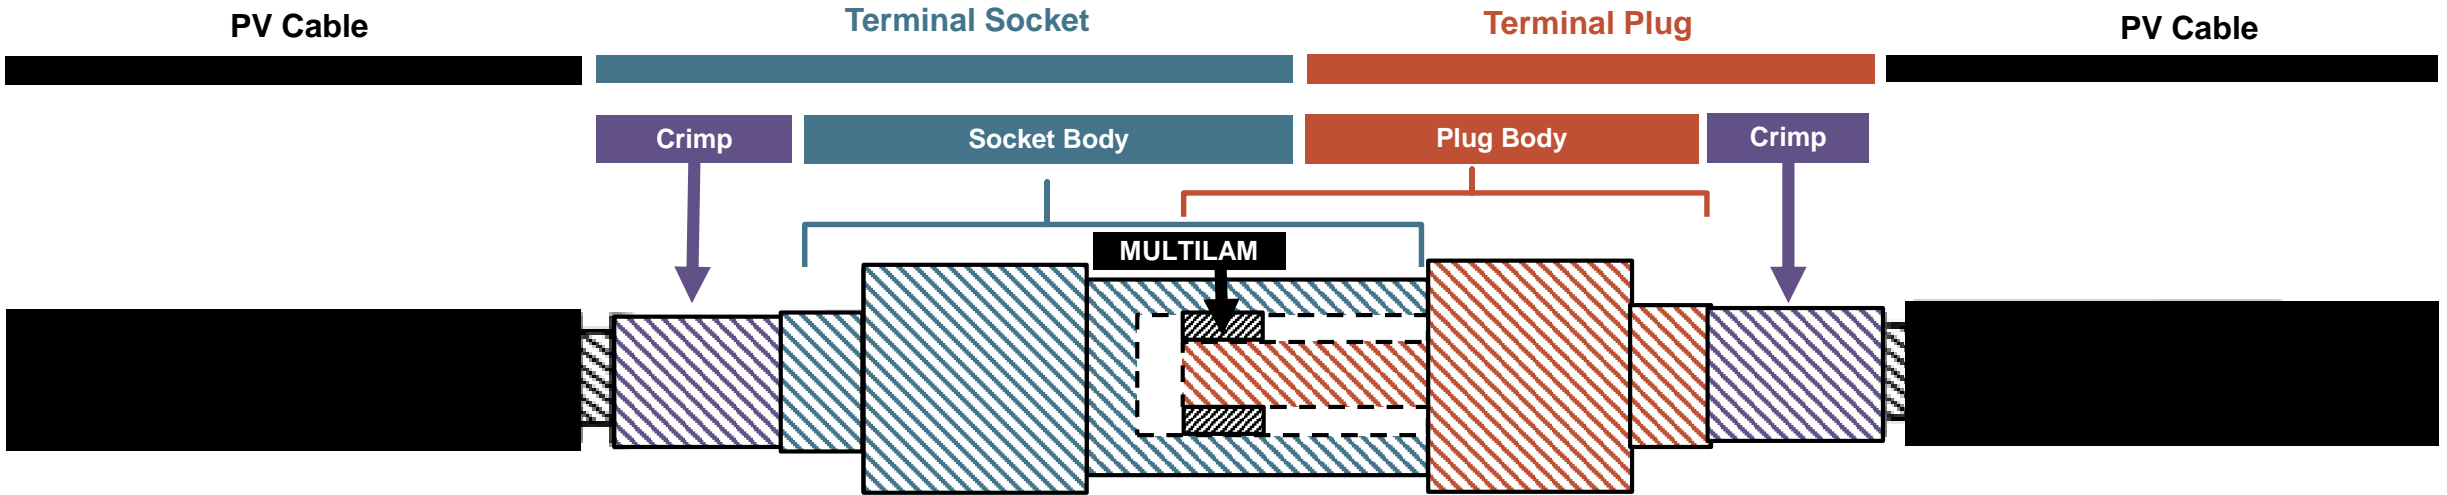
1) Component Quality – Resistances within a PV DC connector

Contact Resistance as per IEC 60512-2-2

Focus: Displays quality of electrical contact between plug & socket, value is independent of conductor cross-section size
 Description: Terminal-to-Terminal-Resistance, excl. resistance of crimp and cable,
 Typical value: <0.25 mΩ
 Measurement points are placed on body of socket and plug
 Use case: Data sheets, catalogues, assembly instructions

$$R_1 = R_{BodyS} + R_{MULTILAM} + R_{BodyP}$$

Contact Resistance as per IEC 62852

Focus: Considers crimp quality, value is dependent of conductor cross-section size
 Description: Includes crimp resistance and cable resistance
 Typical value:
 2,5mm²: <0.9 mΩ
 4,0mm²: <0.7 mΩ
 6,0mm²: <0.6 mΩ
 10,0mm²: <0.4 mΩ
 Measurement points are placed on cable conductor
 Use case: Certification laboratories

$$R_2 = (R_{CableS} + R_{CrimpS} + R_{BodyS} + R_{MULTILAM} + R_{BodyP} + R_{CrimpP}) - 2X(R_{Cable})$$

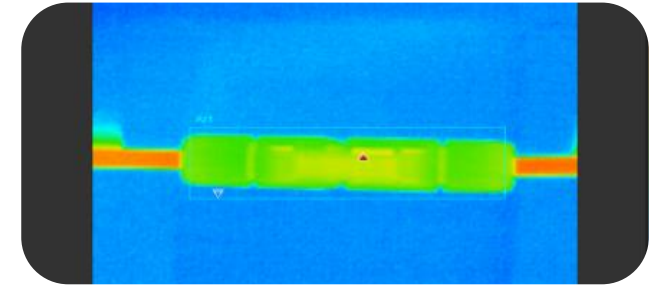
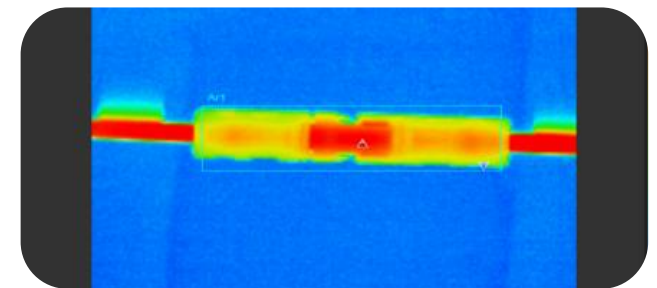
MC4 (MULTILAM Technology)

Competitor Product (no MULTILAM)

$T_{Min} = 25^{\circ}C$

$T_{Max} = 45^{\circ}C$

Measurements acc. to IEC60512-5-1

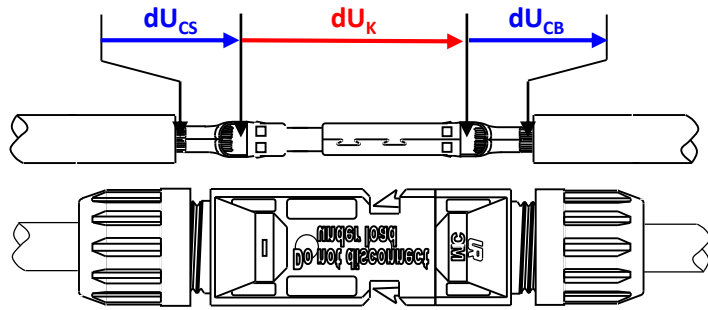
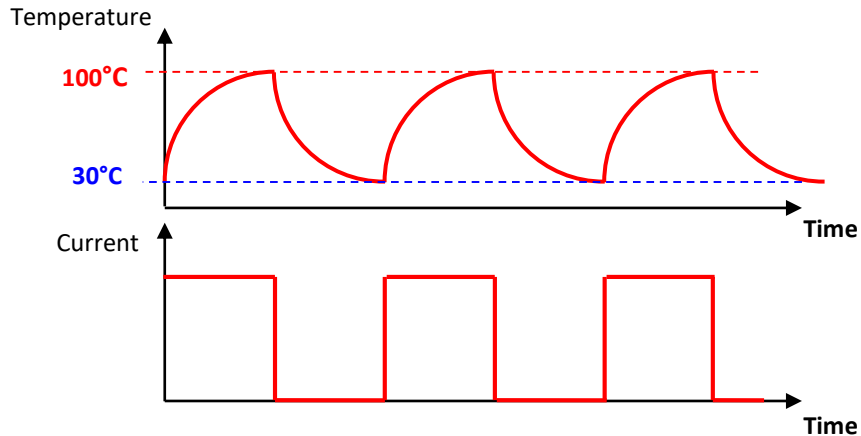
Test Setup

1) Component Quality – Contact Resistance: Laboratory Results

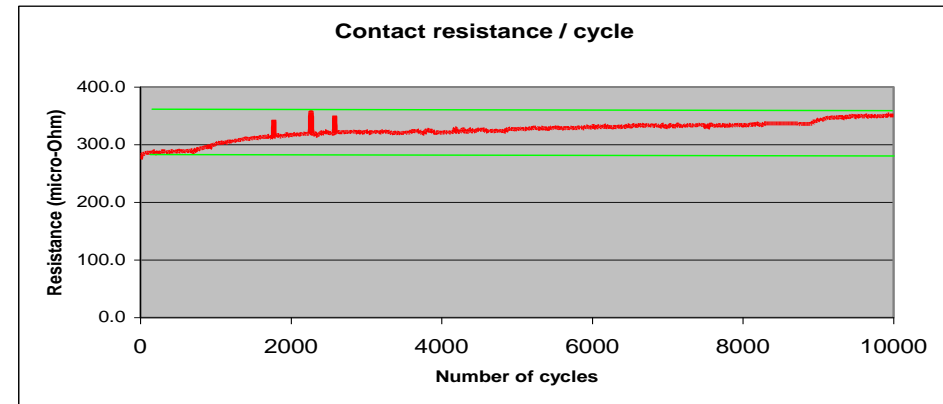
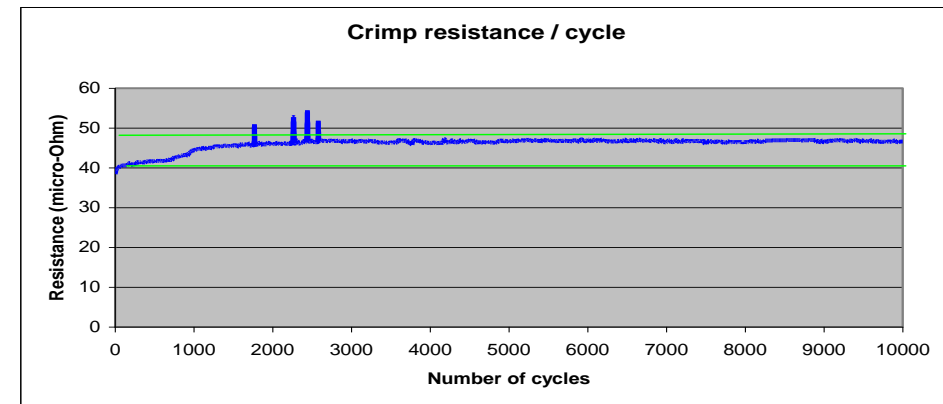
Test Result

10'000 cycles representing ~ 20 years!

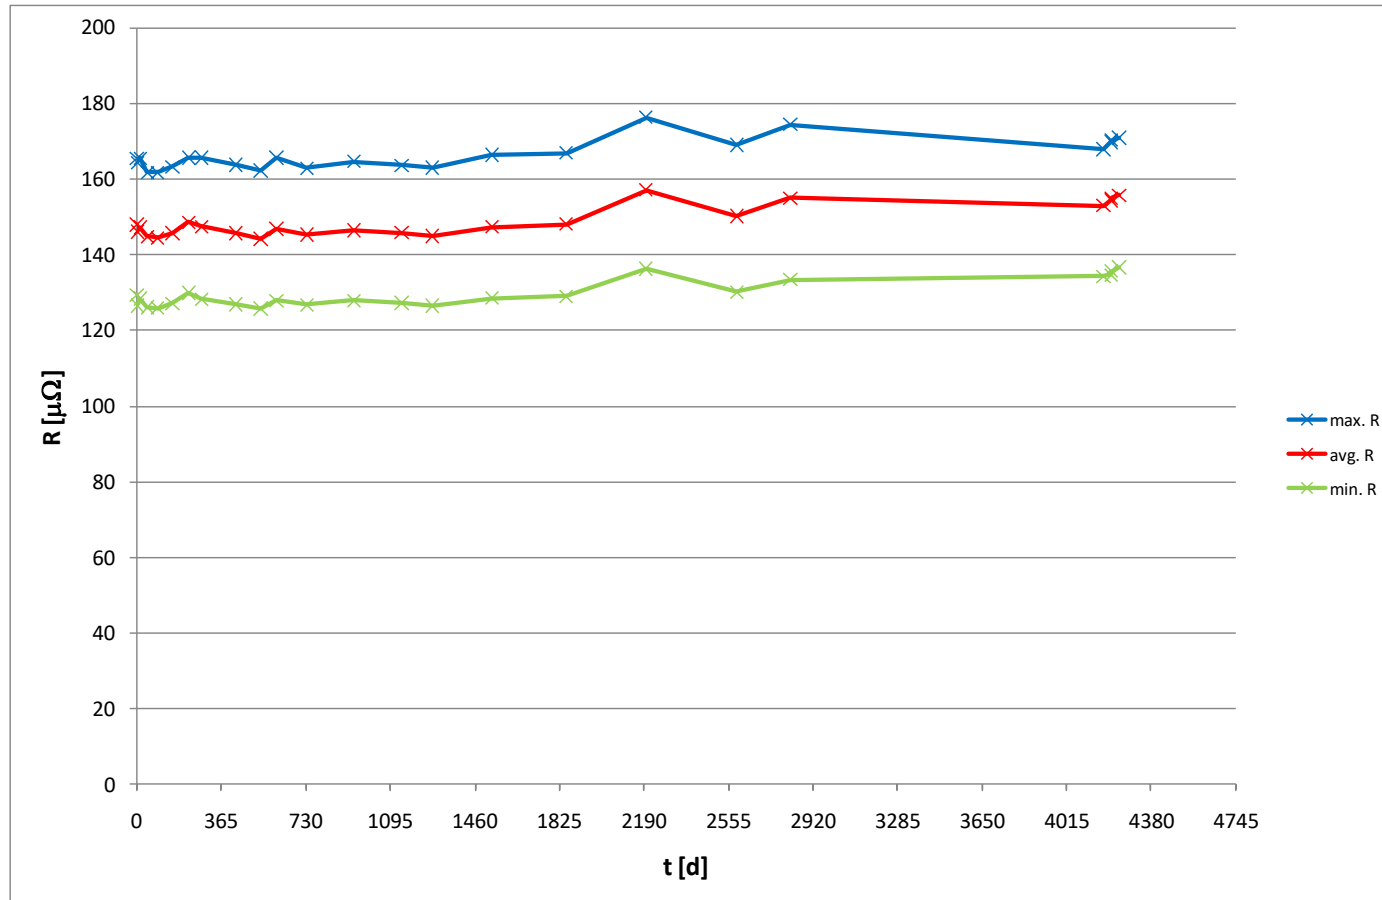
1) Component Quality – Contact Resistance: Field Results

Long-term experience – 12 years on the roof monitoring

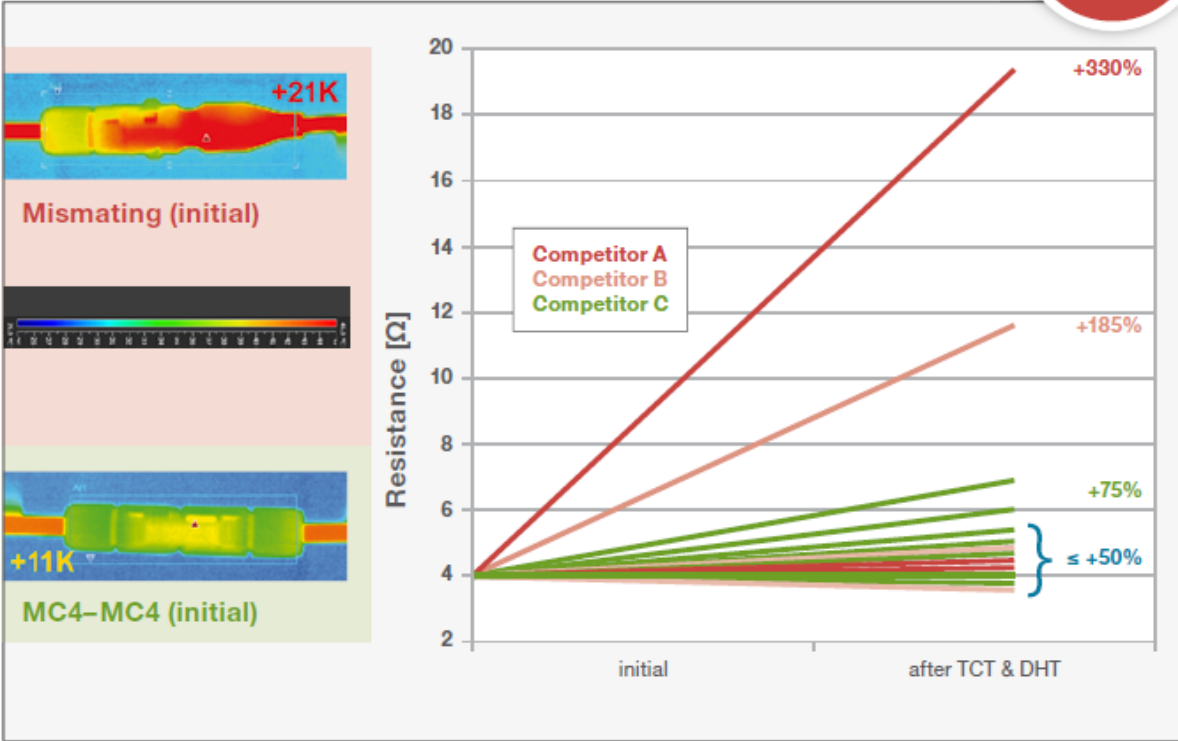
2) Installation – Cross-Connection

Initial Measurements and after TCT/DHT

- High risk for (partial) connector failures
- Performance losses, higher PPM-rates and downtimes of modules, strings or plants
- High service/maintenance and spare part costs for repairing
- Hotspots and fire in PV system and reconstruction costs
- High costs for legal disputes due to undefined liabilities

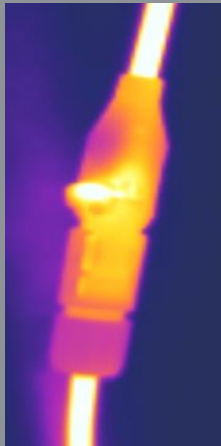
After 5min: heavily smoking
 Power loss: 800W
 Temperature: >200 °C

100A

200 °C
 150 °C
 100 °C
 50 °C

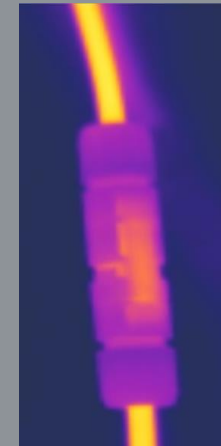
After 5min: no defects
 Power loss: 73W
 Temperature: 135 °C

100A

Technical risk

- Caused by: Different technology, dimensions, product-material, production-process, -capacity, etc.

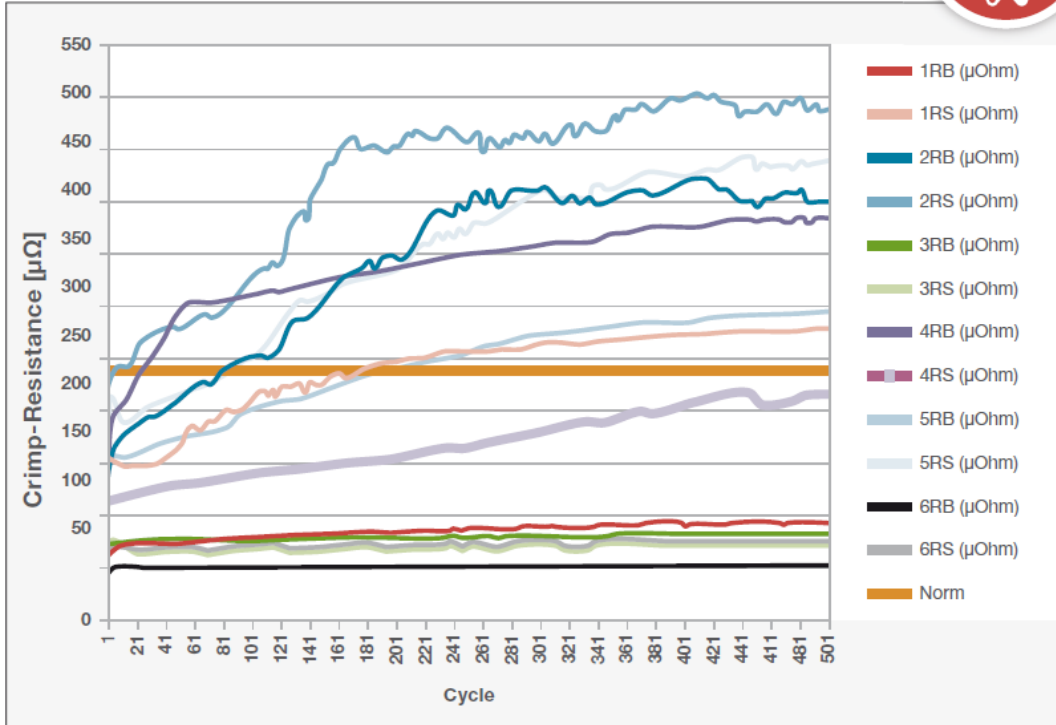
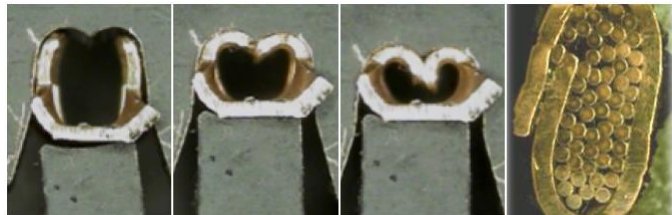
2) Installation – Defective Cable Management (Crimping)

Initial Measurements and after TCT

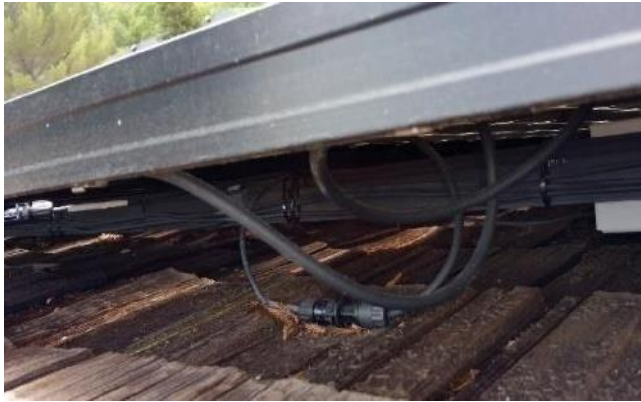
Connectors/ cables directly placed on roof or ground surface

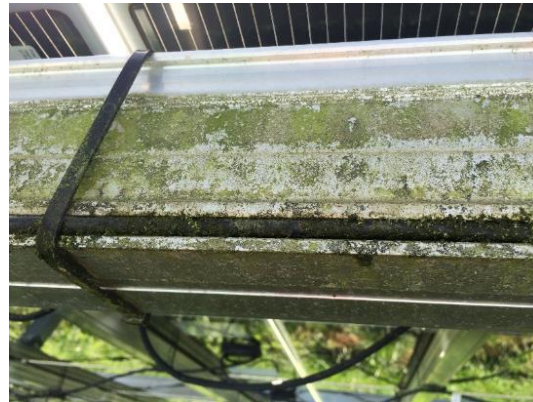
Cable permanently exposed to water

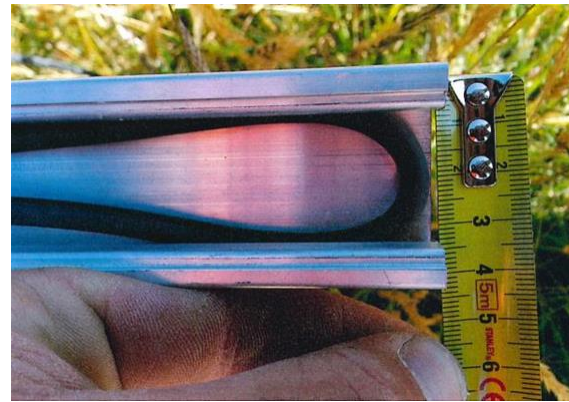
Excessive tension and sharp bending radius

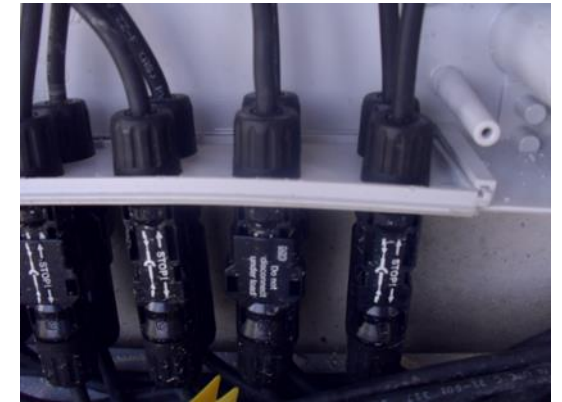
Error in product selection and configuration

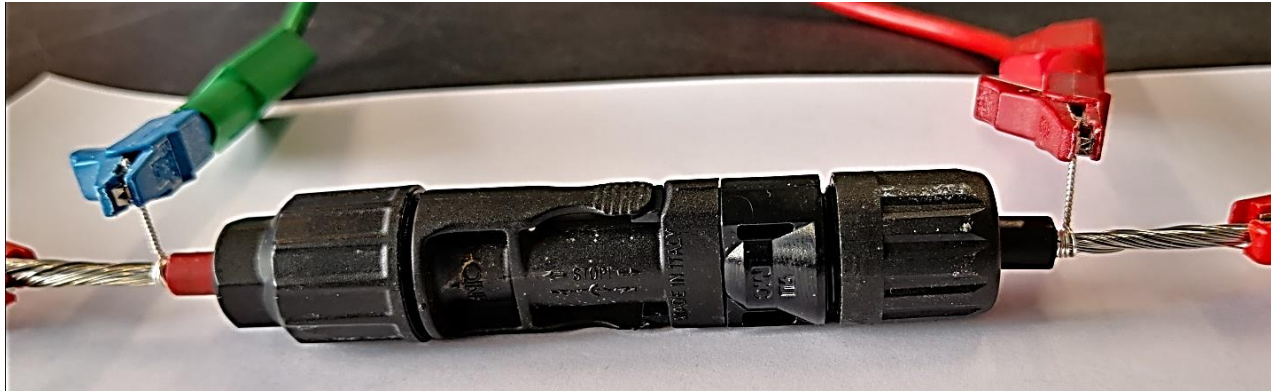
Laboratory testing:
Connections 5 years after commissioning

Insulation Resistance

$R > 400 \text{ M}\Omega$

Original x Original \emptyset	1660,00 $\text{M}\Omega$
Cross-Connection \emptyset	0,06 $\text{M}\Omega$

Contact Resistance

$R \emptyset 530 \mu\Omega$

Original x Original \emptyset	532 $\mu\Omega$
Cross-Connection \emptyset	6841 $\mu\Omega$
